# INTERGOVERNMENTAL OCEANOGRAPHIC COMMISSION (UNESCO)

Nineteenth Session of the International Co-ordination Group for the Tsunami Warning System in the Pacific (ICG/ITSU-XIX).

## EVALUATION OF THE PHYSICAL VULNERABILITY TO EARTHQUAKES AND THEIR ASSOCIATED PHENOMENA, NARIÑO COAST (COLOMBIA).

Cooperation Agreement N° 1005-04-408/2002 National Calamity Fund - Corporación OSSO.

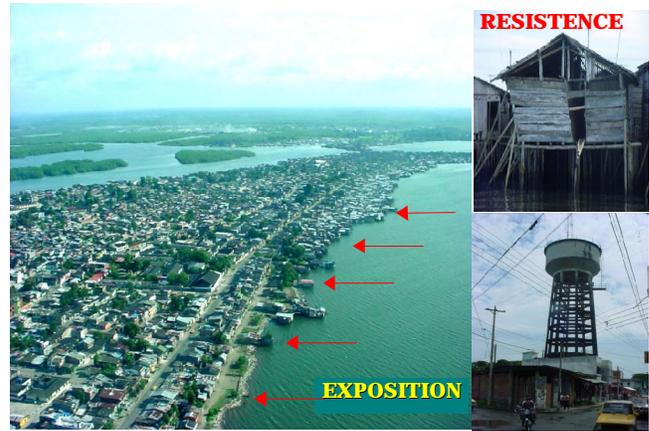
Picture 1. Aspects of exposure and resistance.

We worked with two approaches to evaluate the physical vulnerability in a qualitative way, with an intermediate level, that is to say, without evaluation of individual structures. The first one, a definition of exposure scenarios based on thematic cartography: maps of liquefaction potential (Infgeominas, DIMAR, OSSO, 2002) and floodability (DIMAR - CCCP, 2002), historical information (oral tradition, previous documents) and field observations. The second one was an evaluation of the resistance of the exposed elements to the threats of the considered phenomena, based on constructive and structural characteristics, age, conservation conditions, materials and their arrangement on the land.

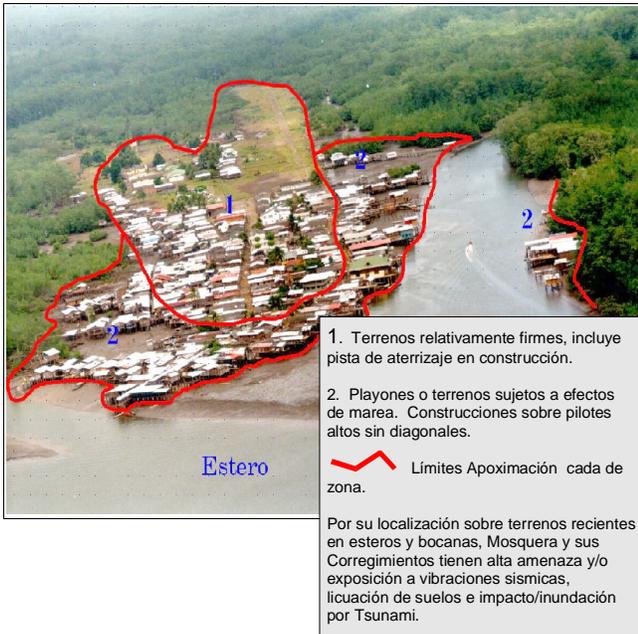
**Picture 2.** Sectorization of the Mosquera municipality.

The other populations were zoned based on physical - environmental and constructive typologies criteria, with field work and aerial inspections. Picture 2 illustrates the case of Mosquera.

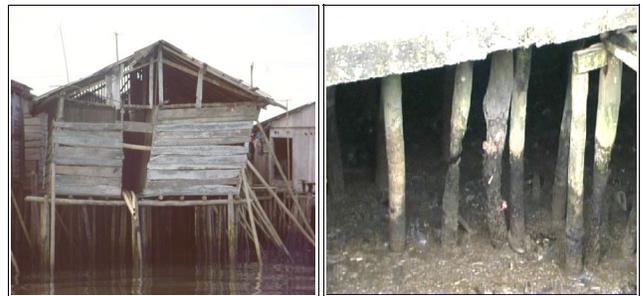
**Picture 3.** House of damaged wood.

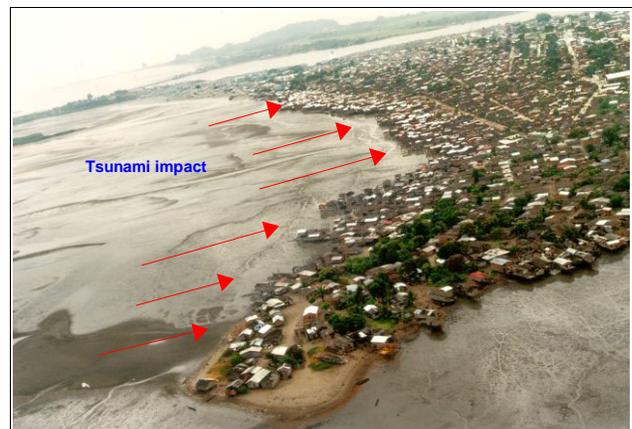
**Picture 4.** Direct exposure to the tsunami impact, in sector 1 of the Tumaco Island.

80% of the populations have a high to extreme degree of exposure to tsunami impact, because they are in front of the sea, without the protection of low seas lands (lower) or wave-obstructing forest, with no high places or any areas appropriate for evacuation. The remaining 20% has minor exposure, since these are far from the coast. However, their degree of exposure to seiches can be high.

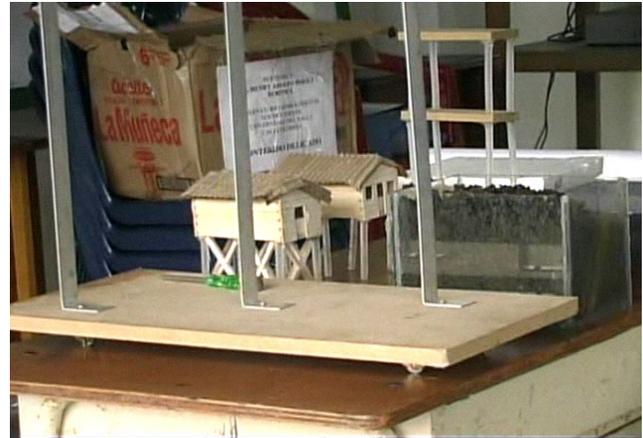
The socialization of this project was carried out with public and private institutions, aid organizations, municipal authorities and communities. It included radio and local TV programs and workshops about the threats, land typologies, and mitigation considerations for the phenomena under study. Scaled models of typical housings on shake-tables were used for illustration, with and without reinforcement, mounted on glass boxes that were artificially induced to liquefaction

with a wooden board on wheels.

**Picture 6.** Didactic models with the purpose of showing the vibration of the ground (seismical table), liquefaction (sand boxes) and the housings turn over (miniature model).

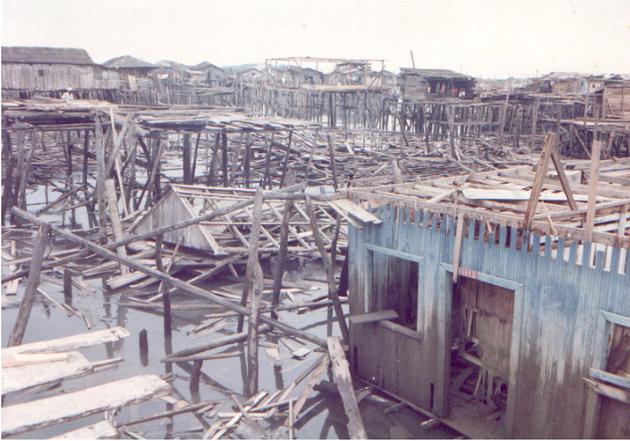
**Picture 7.** Destruction of pile-supported housings, Tumaco 1979.

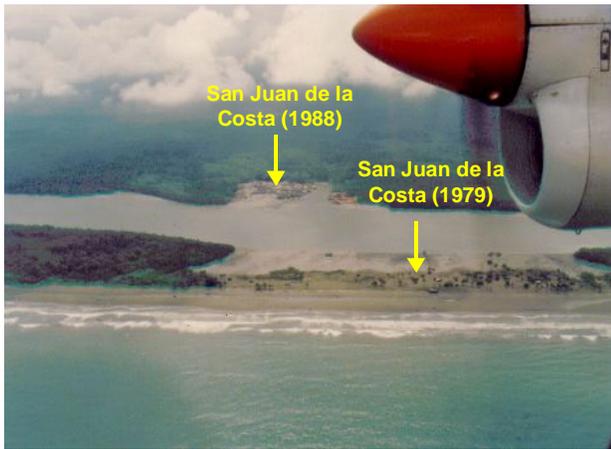
The impact of the tsunami of 1906 led to the relocation of towns near the sea to an inland location, in estuaries protected by forest barriers or mangrove swamp; this in turn led to changes in the economic activity from "sea-based" to agricultural ones (Mosquera et al., 1999). These authors point out that "... those earlier settlers of the new establishments arisen during the XX century, seem to have forgotten and to reject the risks that forced their grandparents to abandon the beaches."

**Picture 8.** San Juan de la Costa, swept away in 1906 and 1979 (1988).

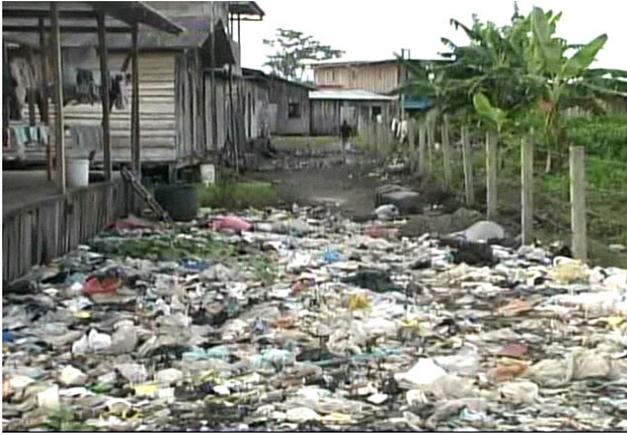
**Picture 9.** Streets covered with garbage, in sectors of urban expansion in the mainland zone, 2003.

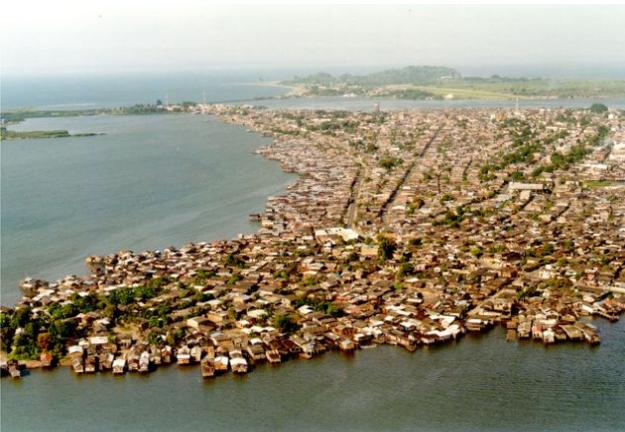
**Picture 10.** Overpopulation of the Tumaco Island, 2003.

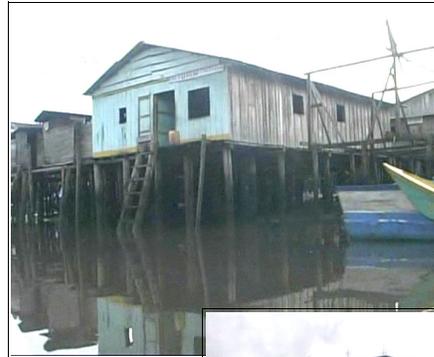
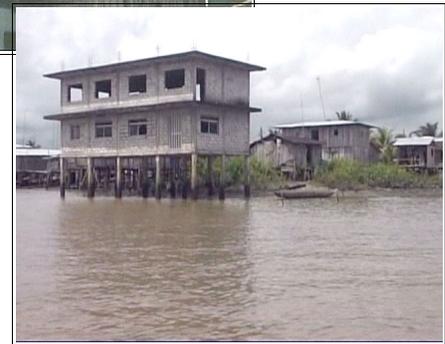
**Picture 11.** Change of flexible materials for rigid ones.

*House made of wood, builded over stakes*

*House made of bricks and concrete, builded over stakes.*
